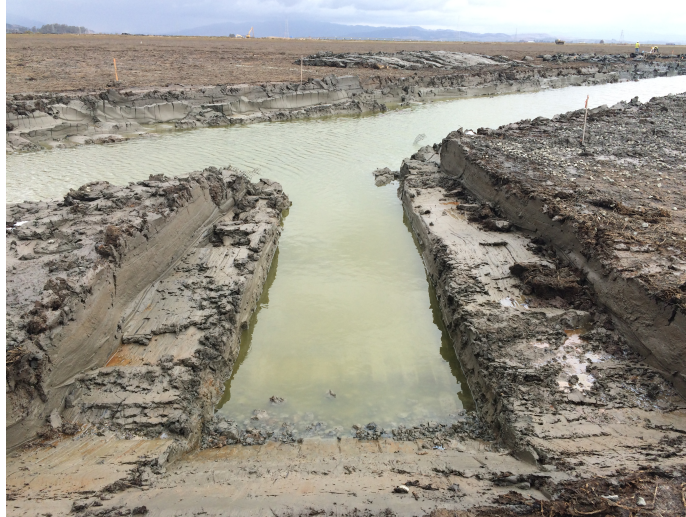
Figure 12. Seven lateral starter channels were cut into the main channel alignment. With the constant flow of water in and out of these starter channels, longer, meandering natural channels are expected to form over time.

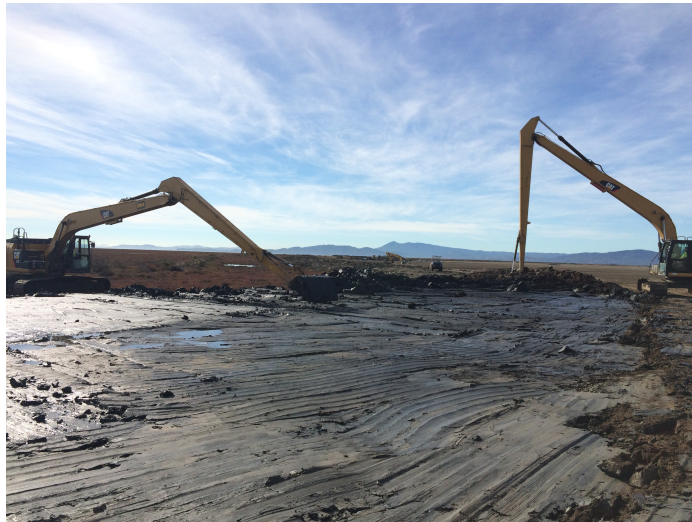
Figure 13. Because construction on the main channel alignment and other projects aspects was complete by 11/15/2015, Hanford was able to complete the formation of the transition ramp in the remaining two weeks of our construction permit window. The final result is approximately 9 acres of transition ramp 120ft wide and 3ft tall from marsh plane to levee, a (40:1) slope, gently sloping habitat ramp. This portion of the project was projected to be shaped in 2017 and

revegetated thereafter. We were able to complete it 2 years ahead of schedule, revegetation will begin in 2016.

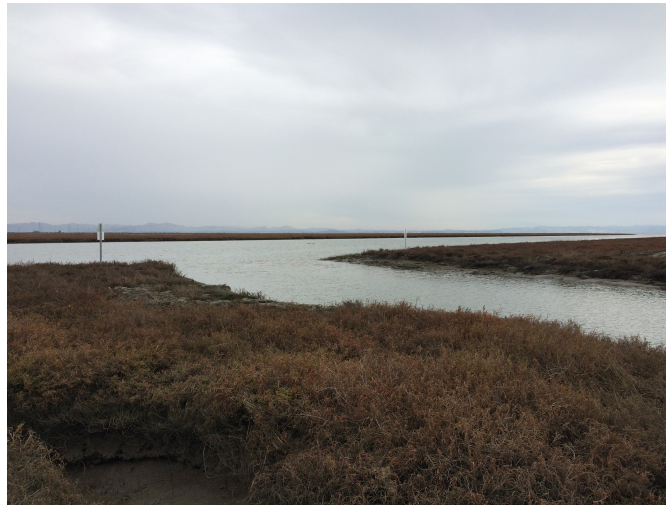
Figure 14. The completed Sonoma Creek Enhancement Project at high tide.

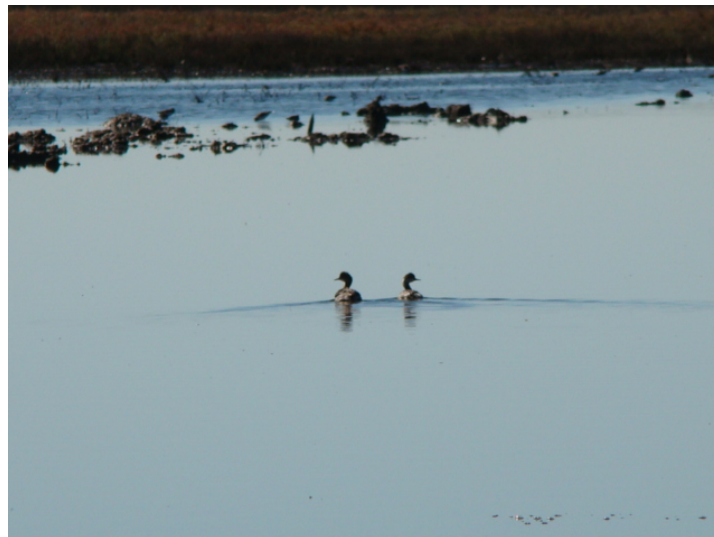
Figure 15. Before 11/20/2015 wildlife are already showing the use of this new habitat as waterbirds swim in the new channel alignment.

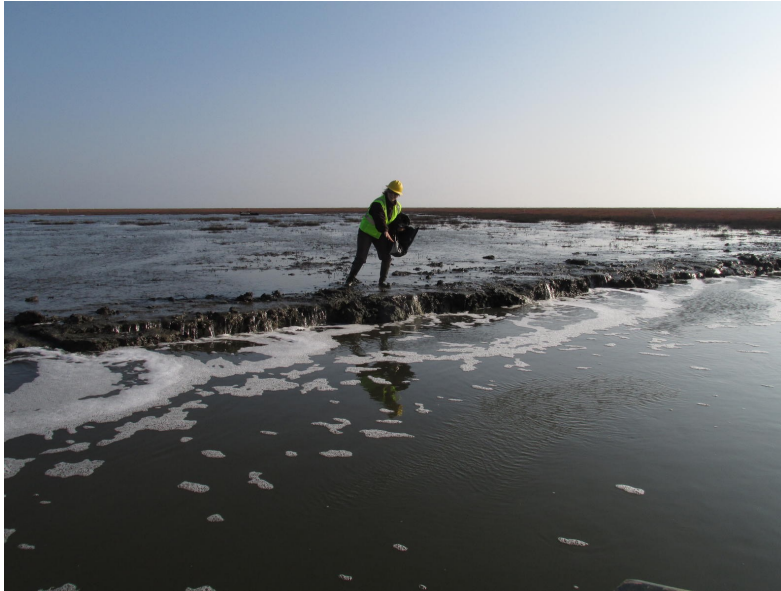
Figure 16. Refuge staff Biologist Meg Marriott is showing how quickly water is flowing off of the marsh (where she stands) into the new channel where it was once trapped on the marsh.

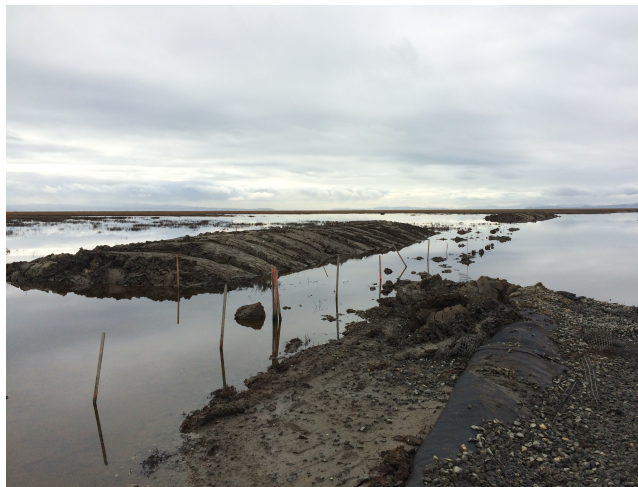
Figure 17. Marsh mounds will provide habitat for wildlife in high tide events. The channel, to the right of the two pictured marsh mounds, cannot be seen in these high tide events.

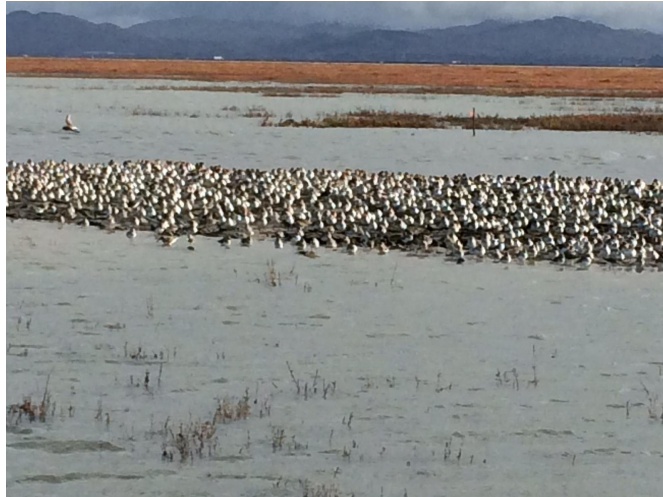
Figure 18. High tide refuge marsh mounds are already proving their necessity as migrating shorebirds, such as these migrating least and western sandpipers, use the elevated tops of the marsh mounds in the king tide events of late November 2015.
